14.00 Yen Himeji Castle The Most Lovely Japanese Landscape Stamp

Souvenir sheet of this stamp was also issued on the same day and the number of issue is only 200 thousand.

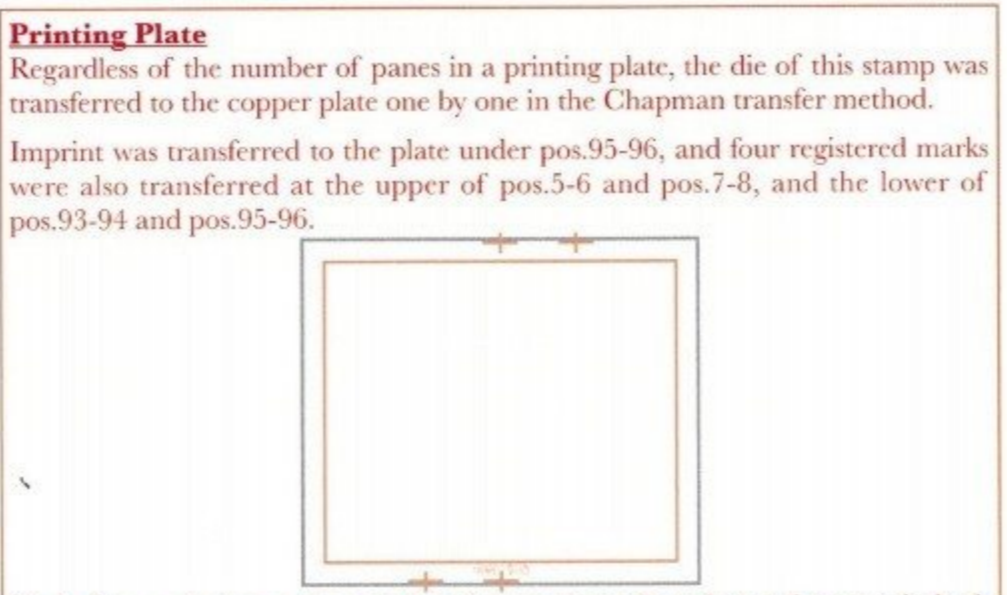
Each distance between the stamp and the registered marks are the same in both panes A and B, however the distance between the imprint and the stamp differs in panes A and B.

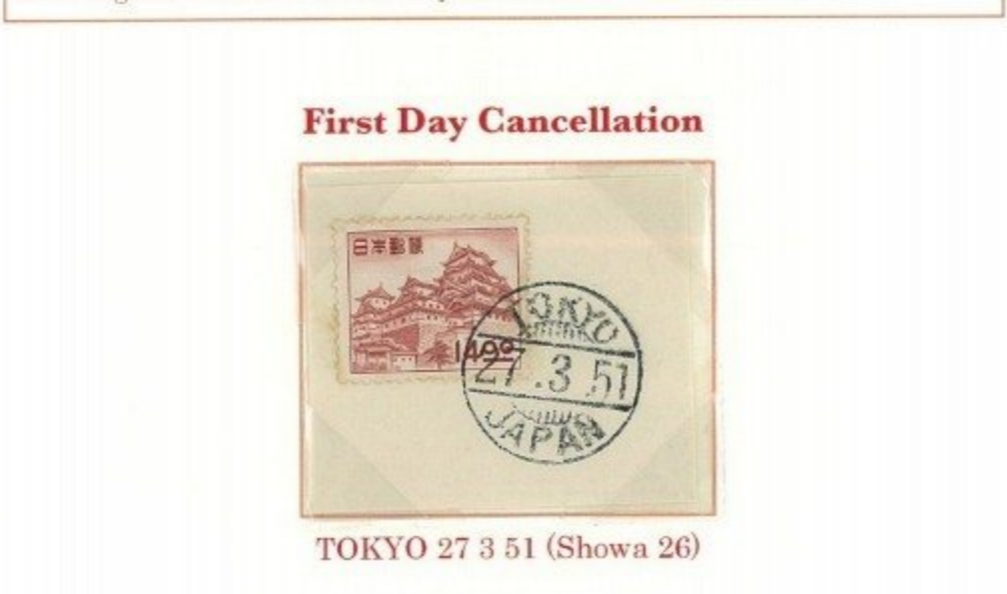
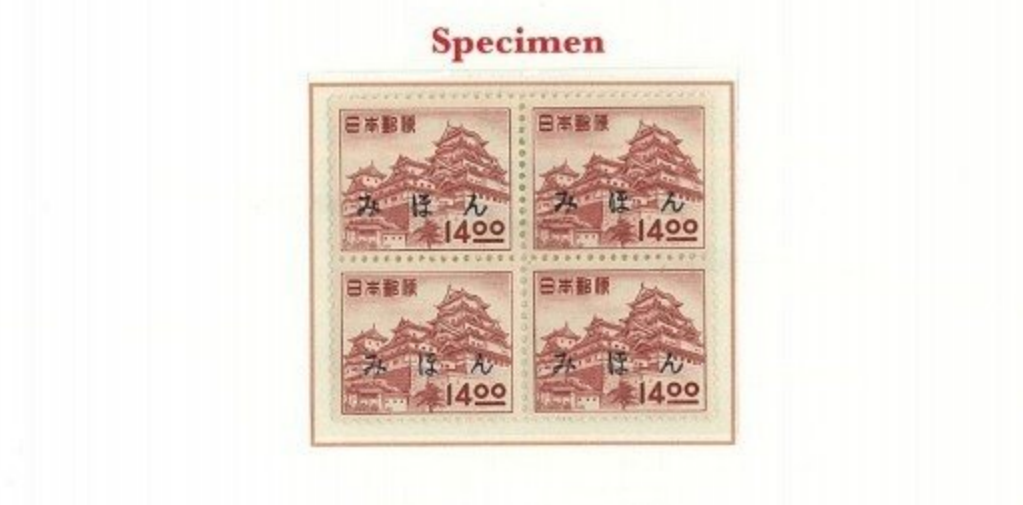
#2 A is an arabic gum and D is a dextrin gum
#3 Distance between stamp and imprint
Engraved plate press was not equipped with any perforation unit, so sheets were transported to perforation machine by hands. Every 5 or 6 sheets were pin-holed at the register mark and then were perforated one row and one row.

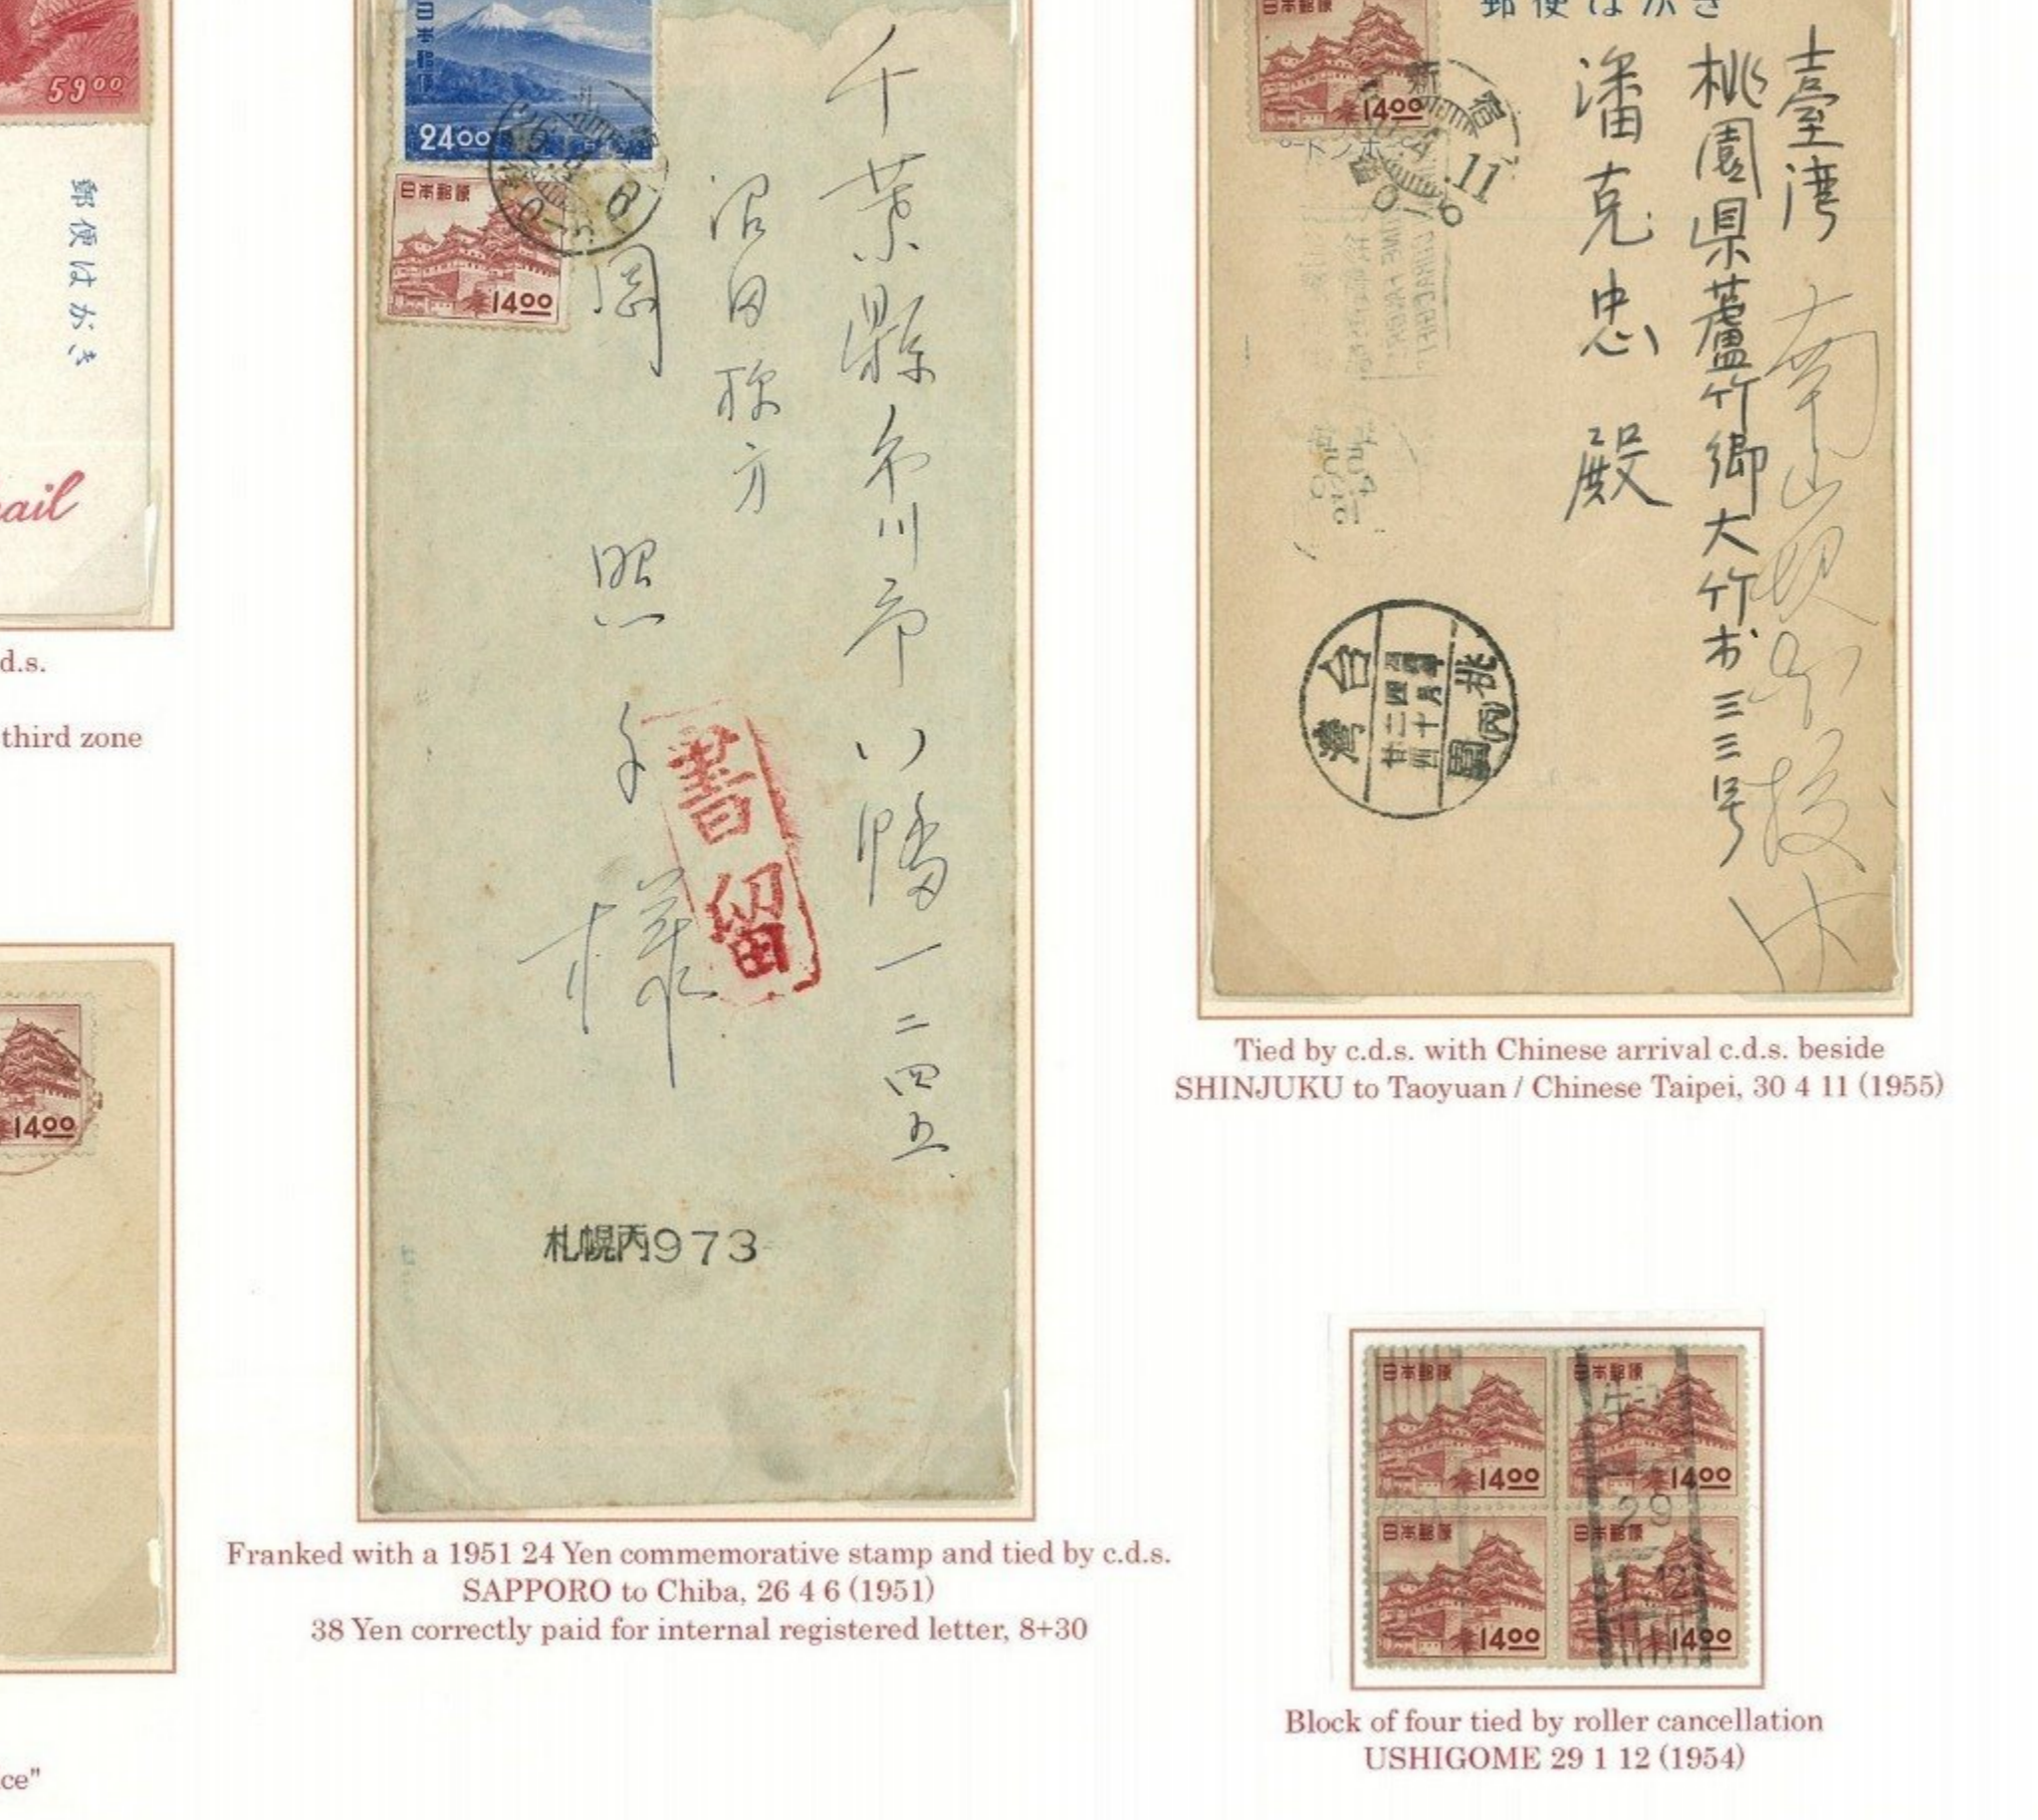
Surface Post Card to Taiwan

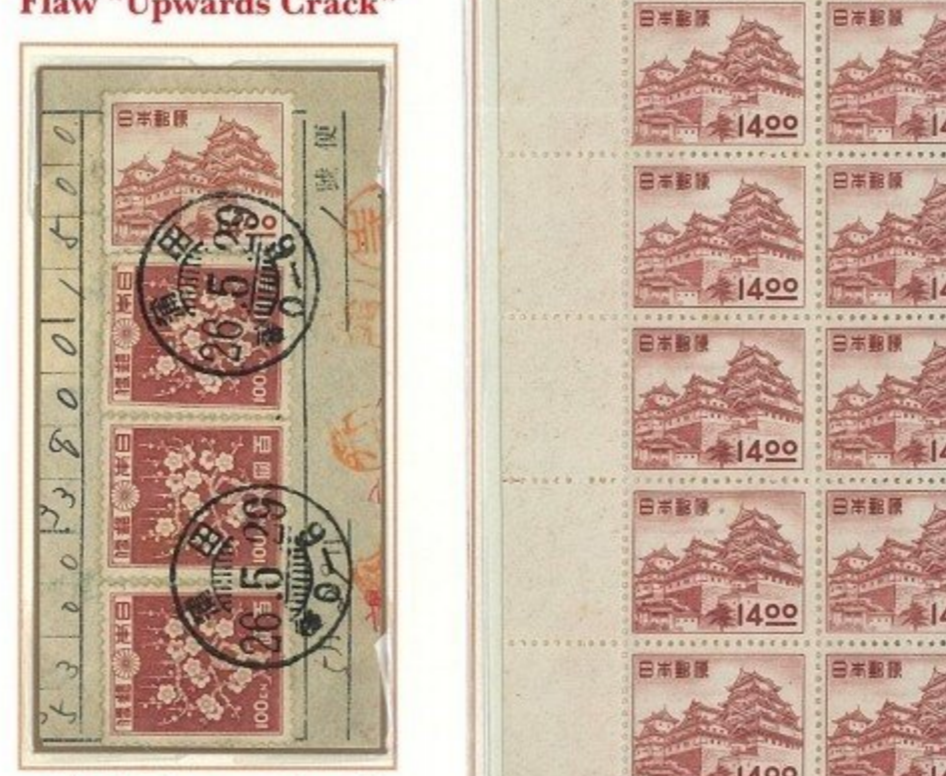
KAMATA 26 5 29 (1951)
Bulk mails payment document

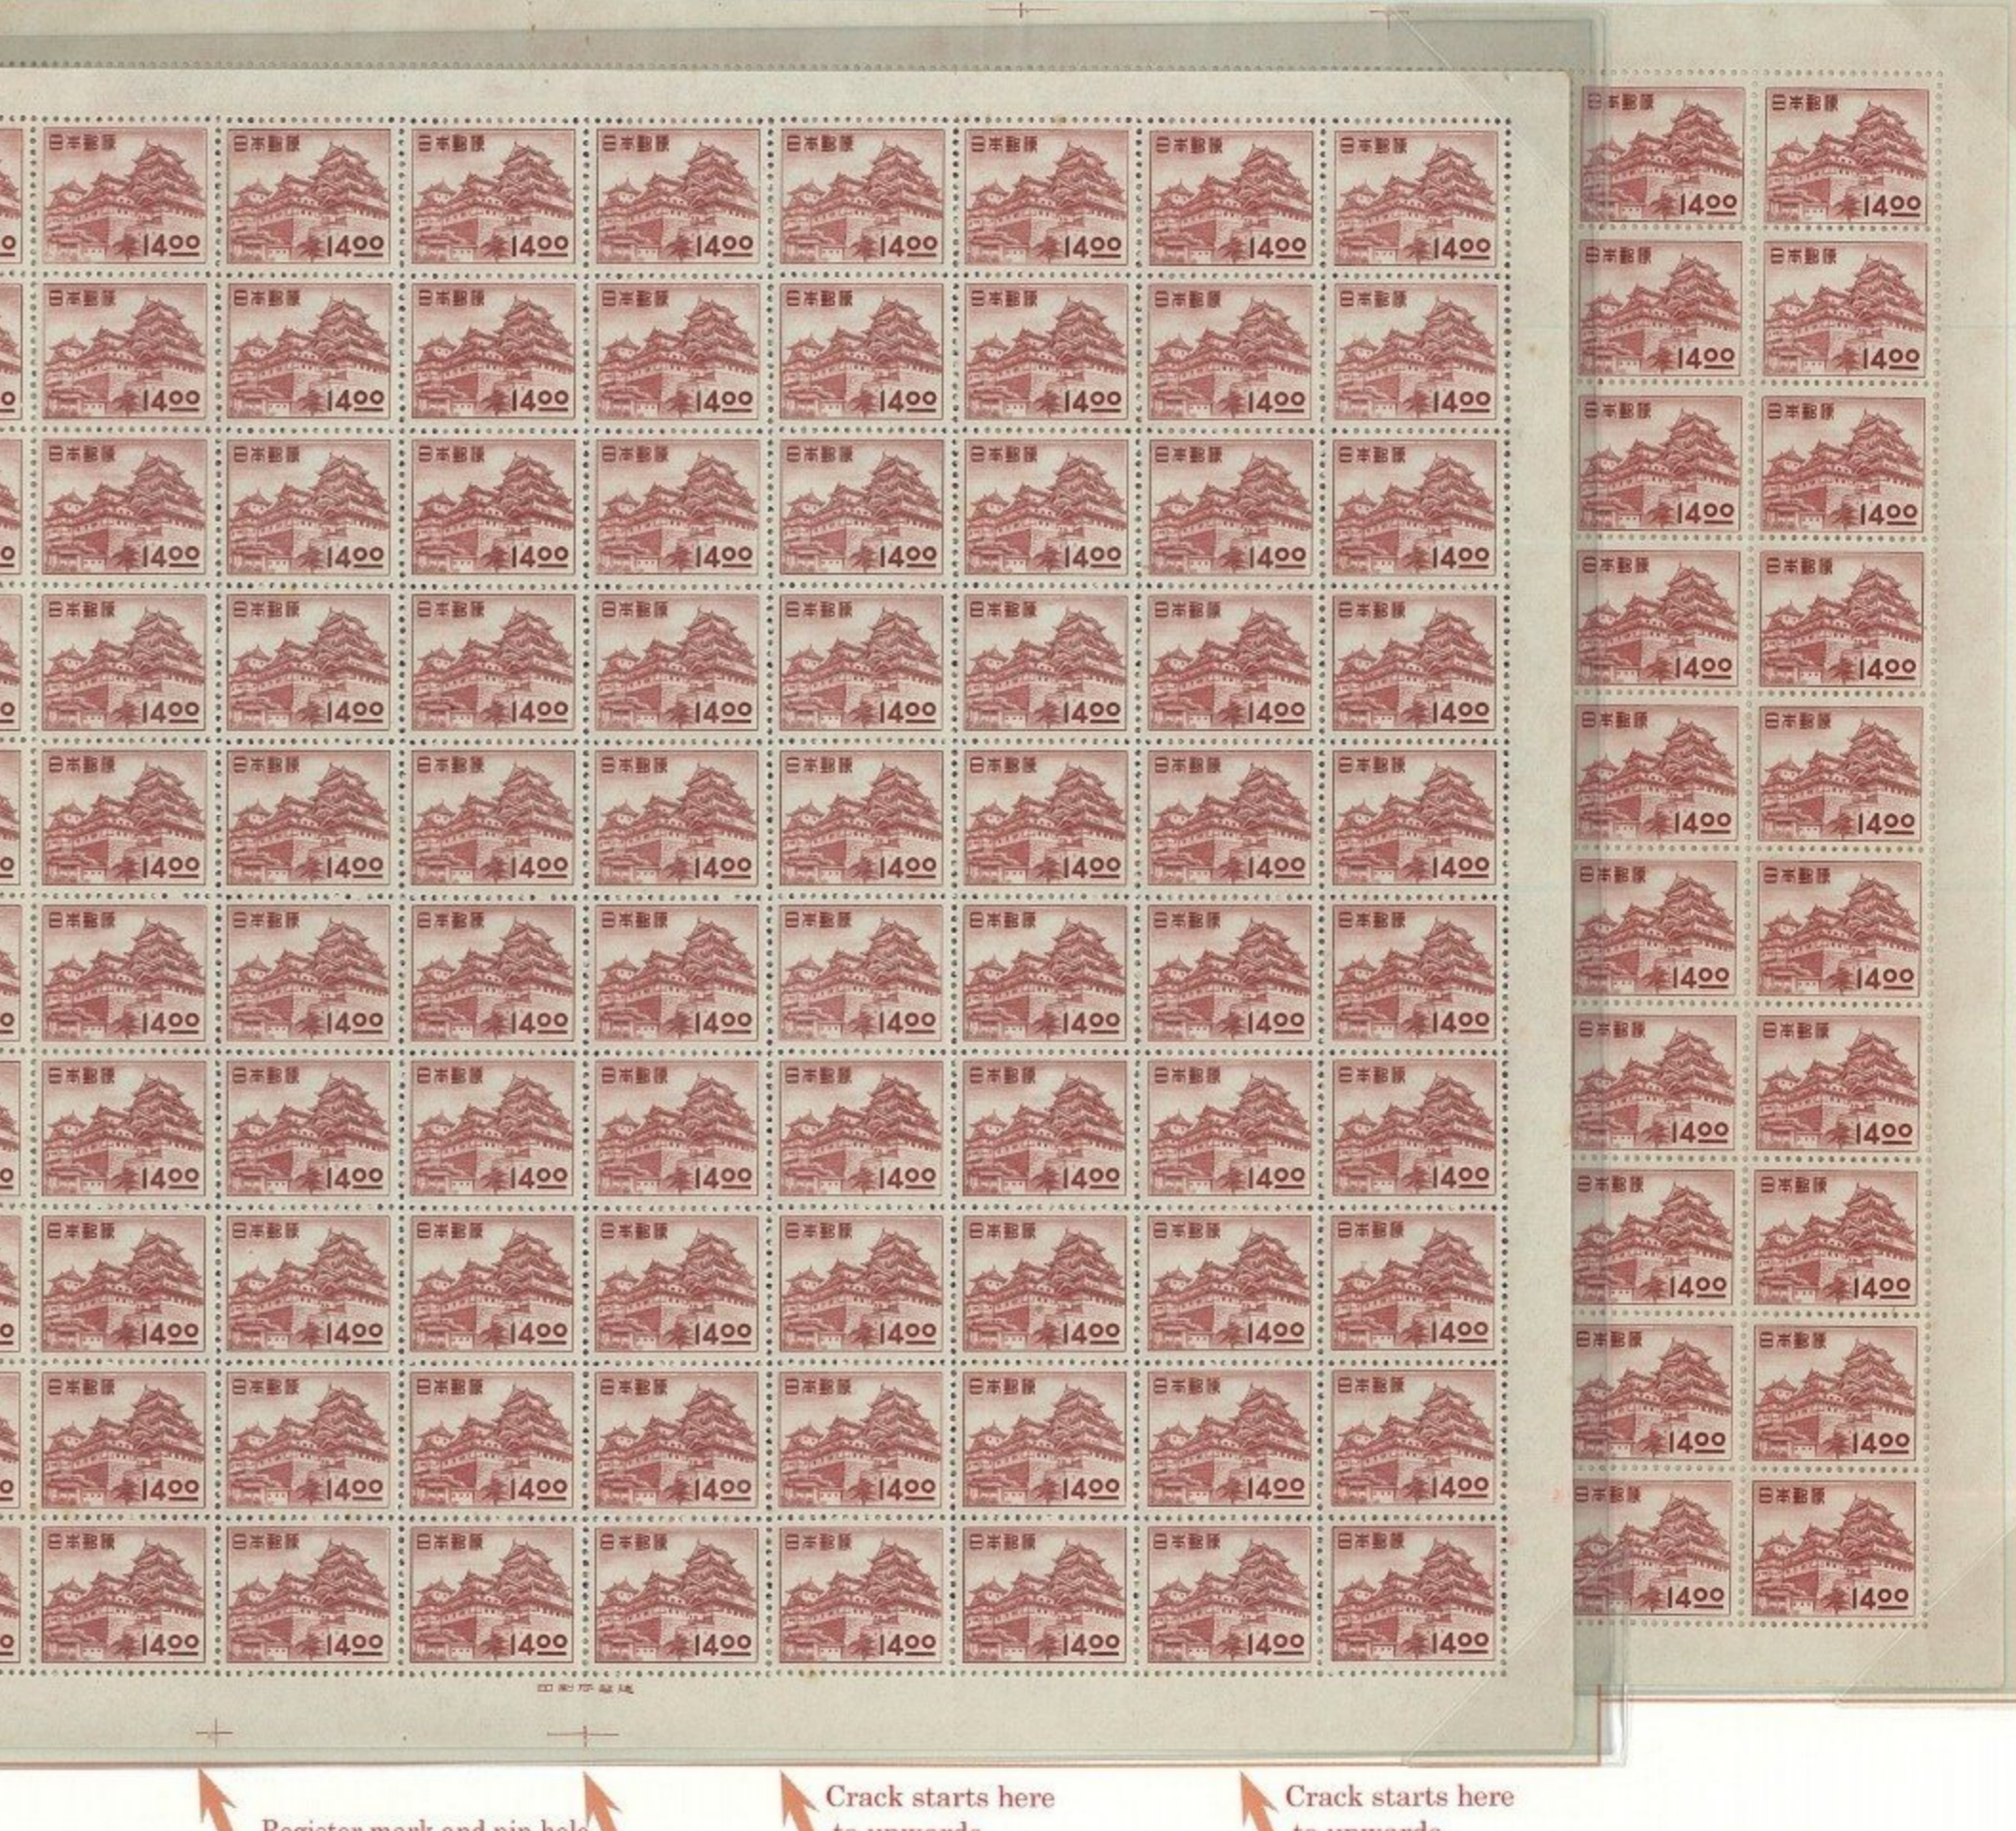
Printing Pane B with Different Staple Position

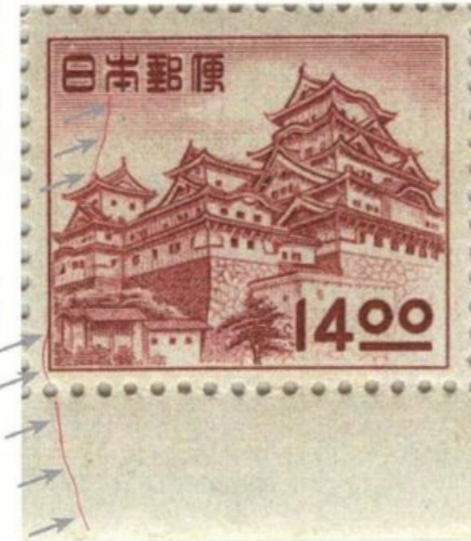
*1 Reported by Mr. Haruna YAMAJI, the Stampedia Philatelic Journal 2012 edition. Several examples

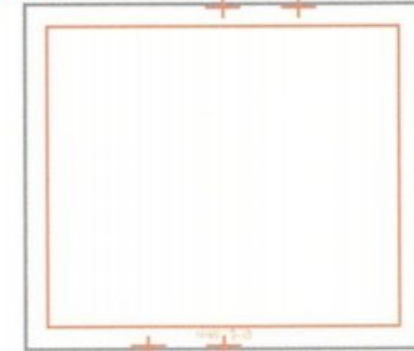
Each distance between the stamp and the registered marks are the same in both panes A and B, however the distance between the imprint and the stamp differs in panes A and B.

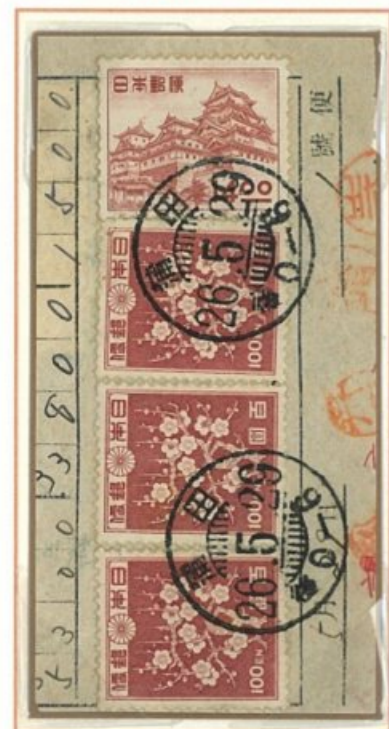
KAMATA 26 5 29 (1951)
Bulk mails payment document
